# From Broken to Beautiful Thanks to **Visalys CemCore**

**Case 1: "Save My Front Cap, Please!"**

**Case 2: Visalys CemCore to the Rescue...Again!**

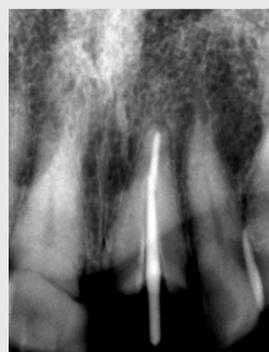
**Figure 4**—Radiograph with metal post

Once my staff captured a periapical radiograph of the affected tooth, I confirmed full seating of the crown and that the marginal integrity was still intact. After preparation of the canal, I used a prefabricated metal post for this "salvage" procedure (Figure 3) and tried in the post to verify the longest supragingival length I could use while achieving full seating of the crown, as confirmed with a check x-ray (Figure 4).

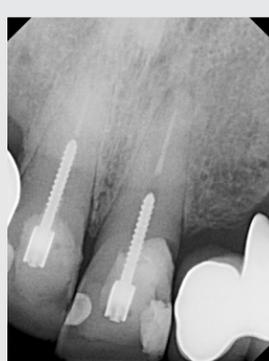
**Figure 6**—Radiograph of tooth Nos. 8 and 9 both with existing posts and buildups

In a separate case, another patient presented with failing teeth Nos. 8 and 9, both of which had previous large existing restorations, including root canal treatment and prefabricated post and core buildup (Figure 6). Upon removal of the existing crowns, both posts and buildups appeared to be intact and stable. The patient elected to proceed with new splinted crowns utilizing the current buildups (Figure 7). On the day of delivery, the patient walked in with a loose temp and—surprise, surprise—the buildup on tooth No. 9 had broken with the pre-existing post still intact (Figure 8).

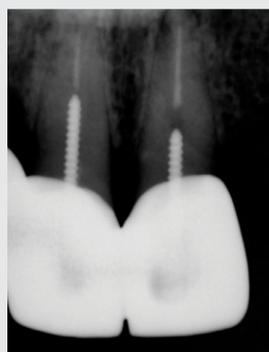
**Figure 9B**—Final cementation of tooth No. 8 and final core buildup and cementation for tooth No. 9

I used my standard bonding technique and utilized the Visalys CemCore in the final cementation for tooth No. 8, and core buildup and cementation for tooth No. 9 (Figures 9A and 9B). Having the confidence that Visalys CemCore is strong and that it would cure and bond without light initiation was vital. The patient and I won on both counts.
